**Re: Navajo Dam Domestic Water Consumers and Mutual Sewage Works Cooperative, Inc.; Water Treatment Plant (WTP); Minor Non-Municipal Individual Permit; SIC 4941, NPDES Compliance Evaluation Inspection; NM0030953; September 5, 2019**

## NPDES Compliance Inspection Report

**Navajo Dam DWC&MSW, Inc. Water Treatment Plant**  
**NPDES Permit No. NM0030953**  
**Compliance Evaluation Inspection**  
**September 5, 2019**

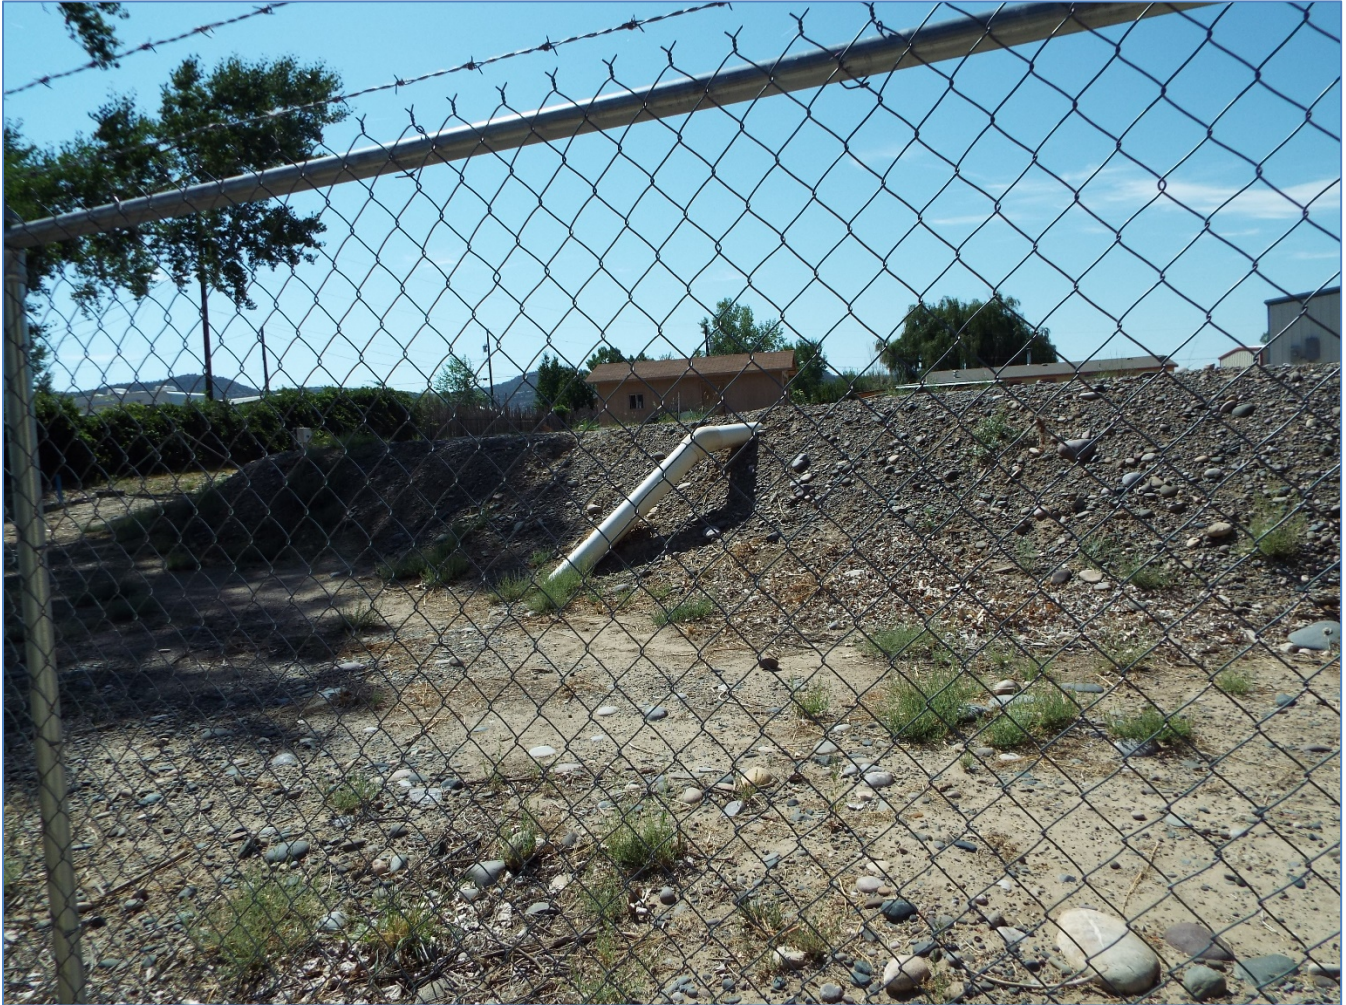
**NMED/SWQB  
Official Photograph Log  
Photo # 1**

Photographer: Daniel Valenta	Date: 09/05/2019	Time: 1132 hours
City/County: Community of Navajo Dam / San Juan County		State: New Mexico
Location: Navajo Dam DWC&MSW, Inc. Water Treatment Plant, NM0030953		
Subject: Discharge pipe outside the settling pond (Pond 2). Vegetation along the bank of San Juan River southern channel was heavy and the outfall could not be seen.

- The Permittee has **not** submitted a renewal application for this no discharge / emergency permit 180 days prior to permit expiration. Permit expires October 31, 2019. Permittee representatives indicated that termination of the permit was under consideration. Contact information was provided to the Permittee representatives to report intention to submit renewal application or terminate the permit. The outfall pipe is capped, but this would not prevent a discharge if the ponds overflowed or emergency were to occur.

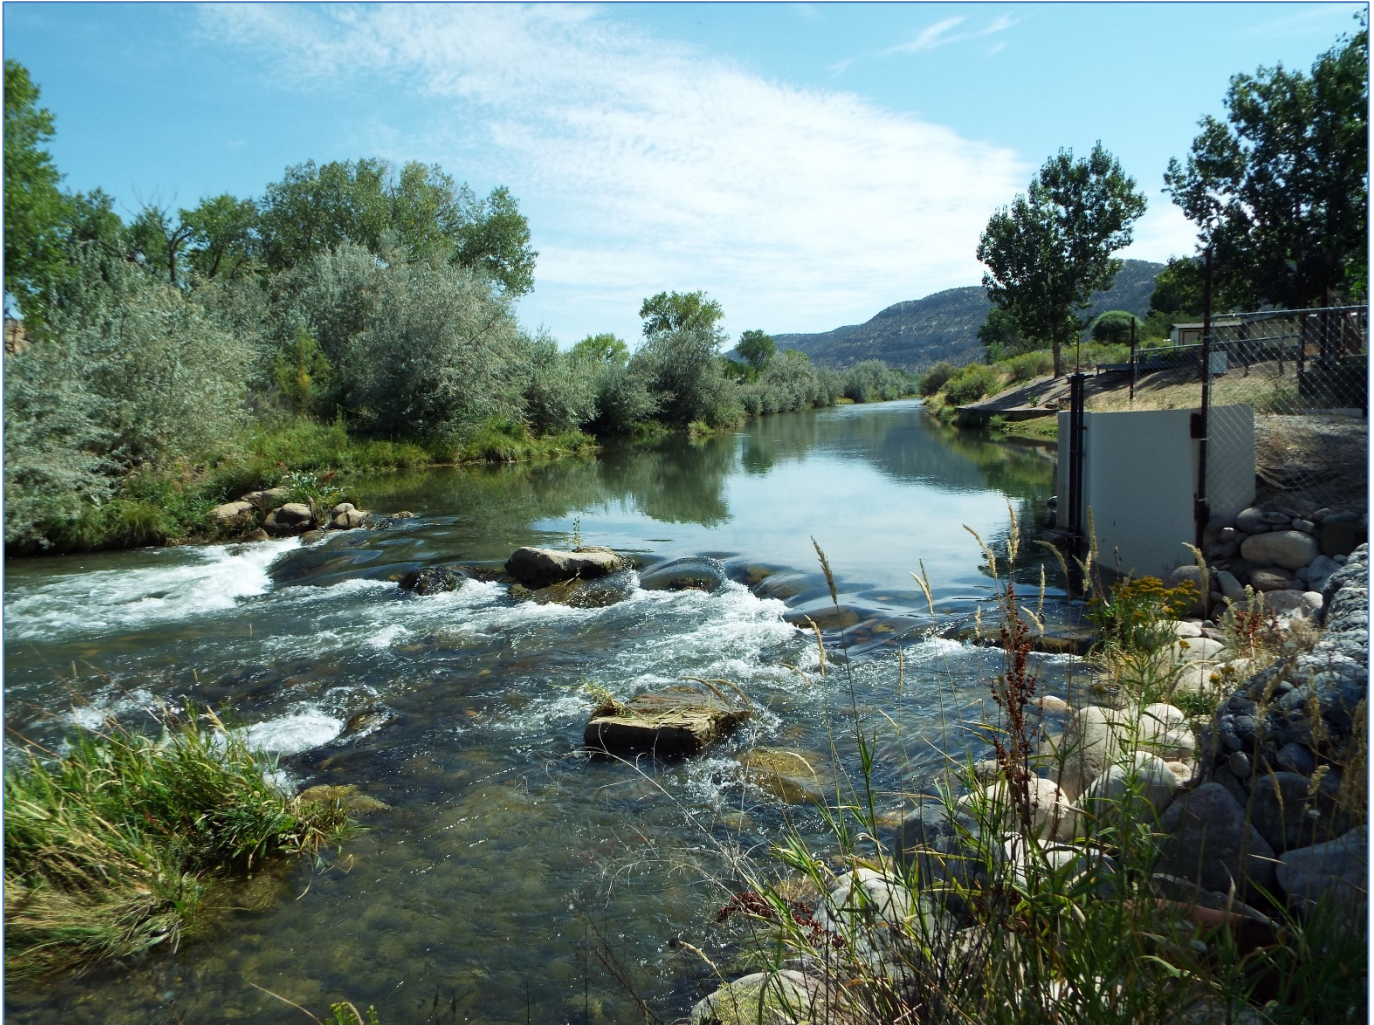
**NMED/SWQB  
Official Photograph Log  
Photo # 2**

Photographer: Daniel Valenta	Date: 09/05/2019	Time: 1133 hours
City/County: Community of Navajo Dam / San Juan County		State: New Mexico
Location: Navajo Dam DWC&MSW, Inc. Water Treatment Plant, NM0030953		
Subject: Looking upstream from WTP infiltration gallery / diversion at San Juan River southern channel.

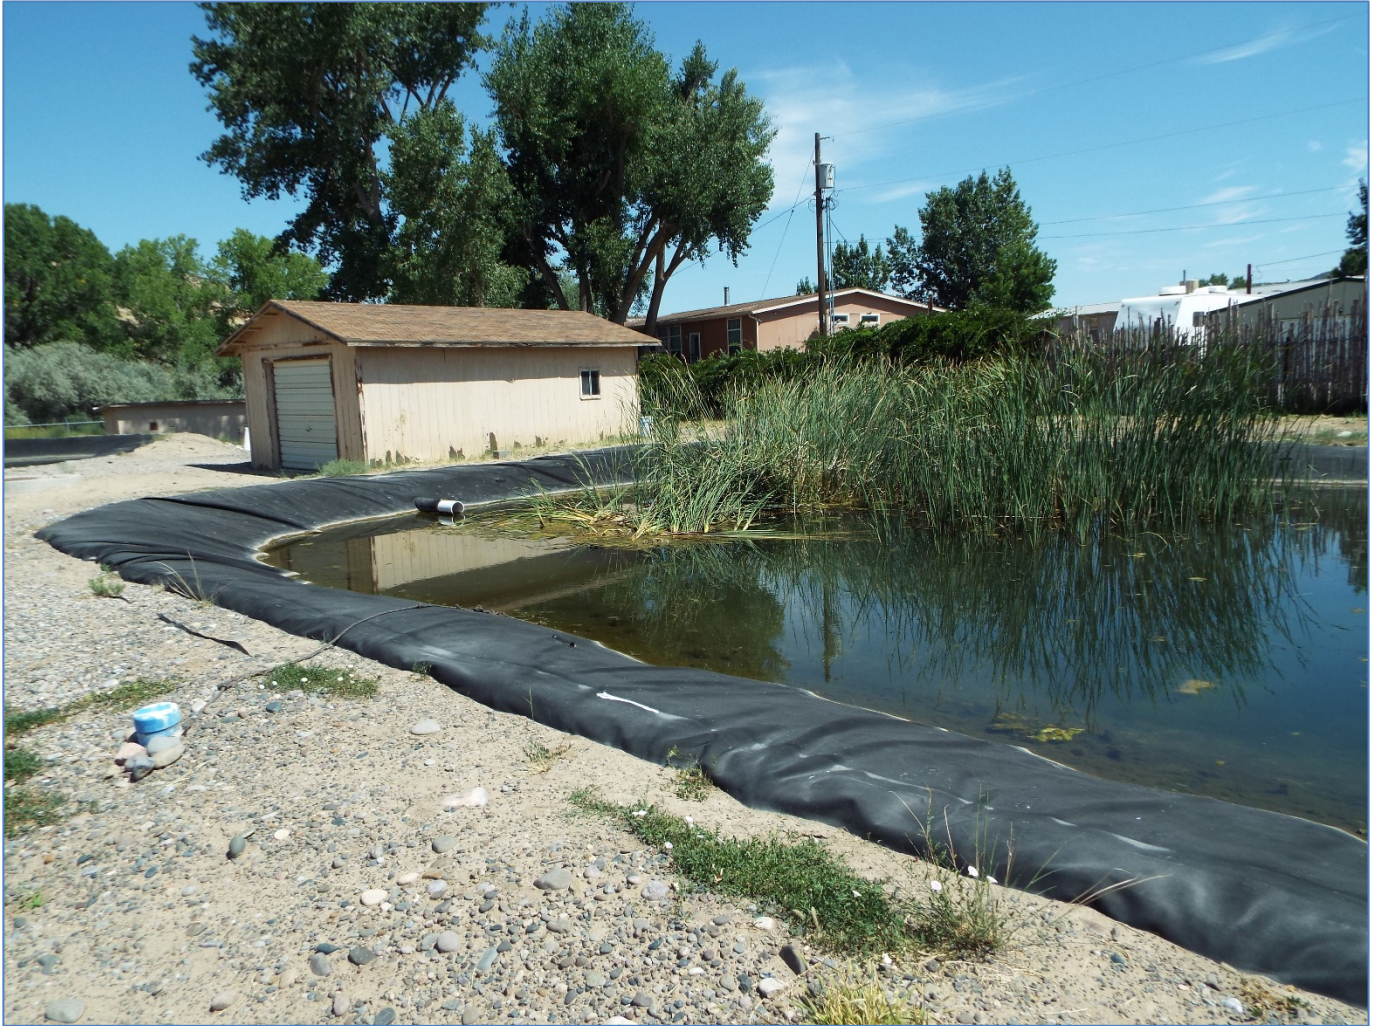
**NMED/SWQB  
Official Photograph Log  
Photo # 3**

- On the day of this inspection, settled and floating solids were observed at both ponds. According to the on-site representatives, ponds were previously drained and cleaned out in 2014; backwash pond had a leak between the liners; and solids from the backwash pond would be removed when the liner is repaired. Details for disposal or reuse of water in upland areas had not been determined. The date for maintenance had not be scheduled.

Photographer: Daniel Valenta	Date: 09/05/2019	Time: 1249 hours
City/County: Community of Navajo Dam / San Juan County		State: New Mexico
Location: Navajo Dam DWC&MSW, Inc. Water Treatment Plant, NM0030953		
Subject: Vegetation was growing inside the backwash evaporation pond (Pond #1). Settled solids and floating algal mats was observed.

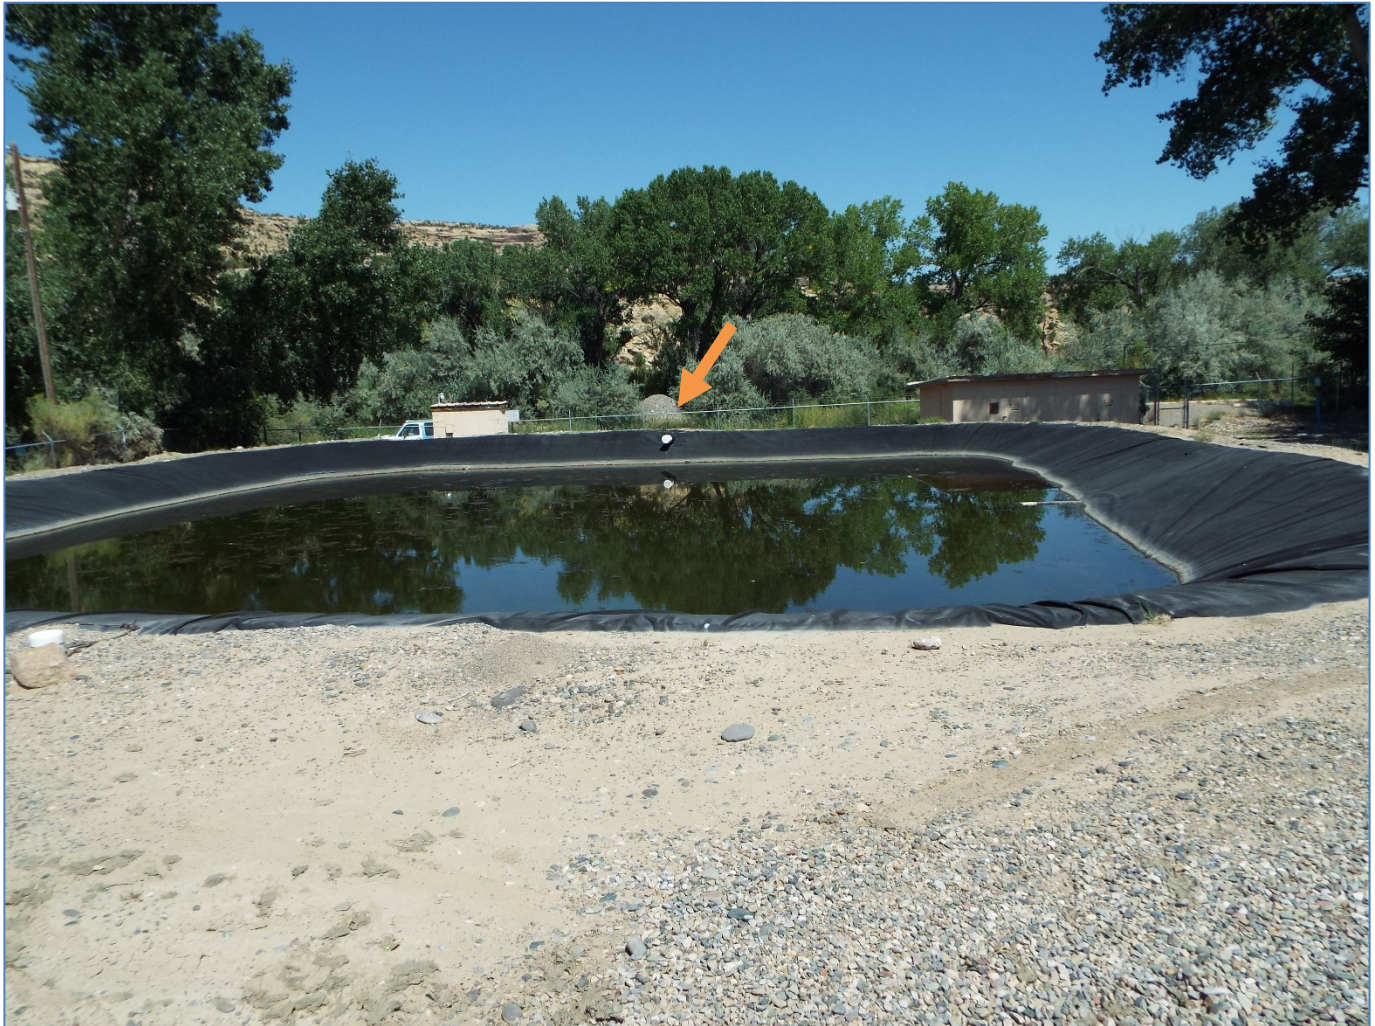
**NMED/SWQB  
Official Photograph Log  
Photo # 4**

Photographer: Daniel Valenta	Date: 09/05/2019	Time: 1250 hours
City/County: Community of Navajo Dam / San Juan County		State: New Mexico
Location: Navajo Dam DWC&MSW, Inc. Water Treatment Plant, NM0030953		
Subject: Settling Evaporation Pond (Pond #2). Arrow points to capped outlet of a pipe installed within the pond liner and berm shown in Photo #1 above.
